ENDURANCE TESTING OF AN LM-726-4
ELASTOMERIC PITCH CHANGE BEARING

Lord Kinematics

Army Air Mobility Research and Development
Laboratory

June 1974

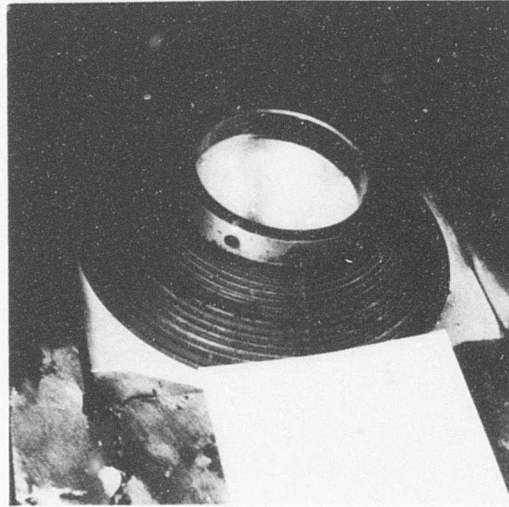
Figure 44. Test Sample 1 (S/N 004) After 1400 Hours of Endurance Testing. (Appearance is typical of Test samples 2, 4, 5, and 6.)

Figure 46. Test Sample 1 (S/N 004) After 1600 Hours of Endurance Testing. (Appearance is typical of test samples 2, 4, 5, and 6.)

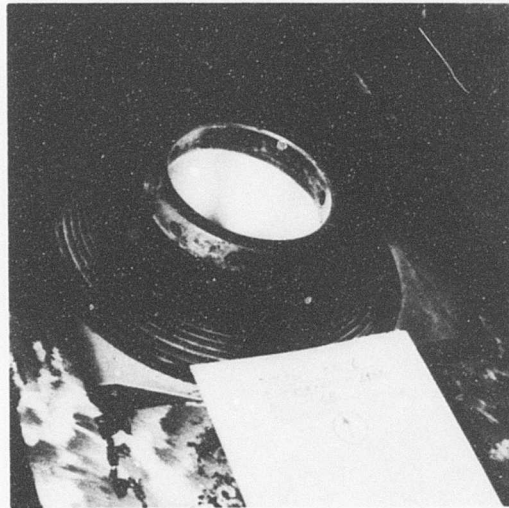
Figure 45. Test Sample 3 (S/N 006) After 1400 Hours of Endurance Testing. (This sample is the most severely damaged at this point of the test. A depth of separation is visible in first layer in left center of photo.)

Figure 47. Test Sample 3 (S/N 006) After 1600 Hours of Endurance Testing. (Most severely damaged sample. Note depth of separation visible in left center of photograph.)
